Ranch Place HOA

Level 1 Reserve Study

Report Period – 01/01/2018 – 12/31/2018

Report prepared on – Friday, August 18, 2017

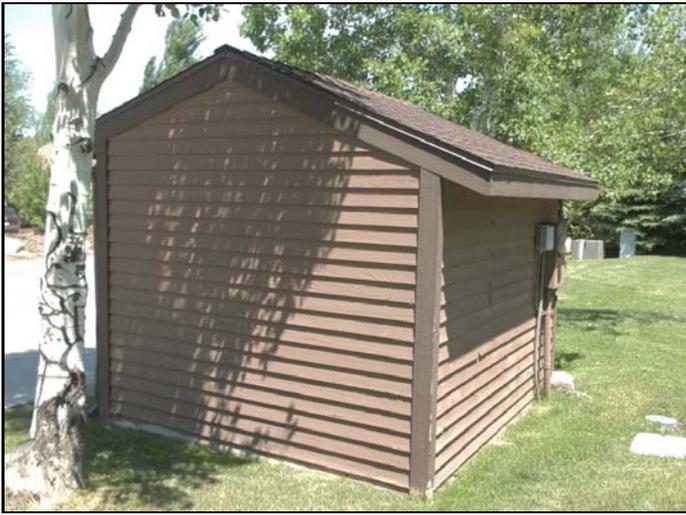
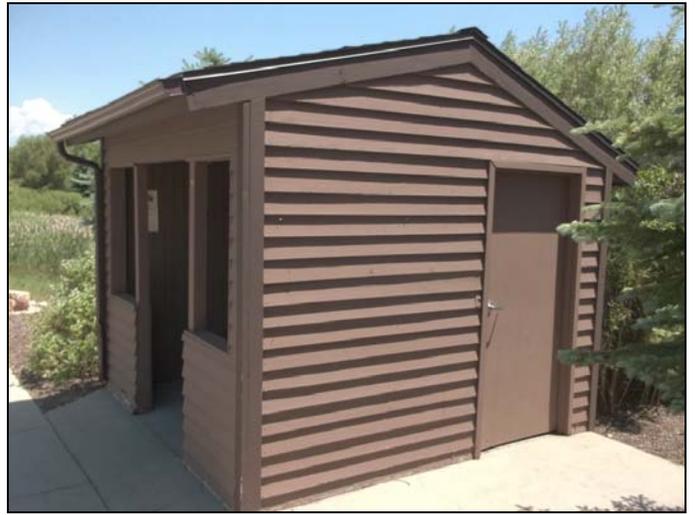
Comp #: 215 Mailbox Structures - Repaint

Research with the client reveals these structures are being replaced in 2017 and 2018. We recommend funding to repaint this component approximately every 6 - 8 years to maintain appearance and to protect wood surfaces. Remaining life is based on current average age.

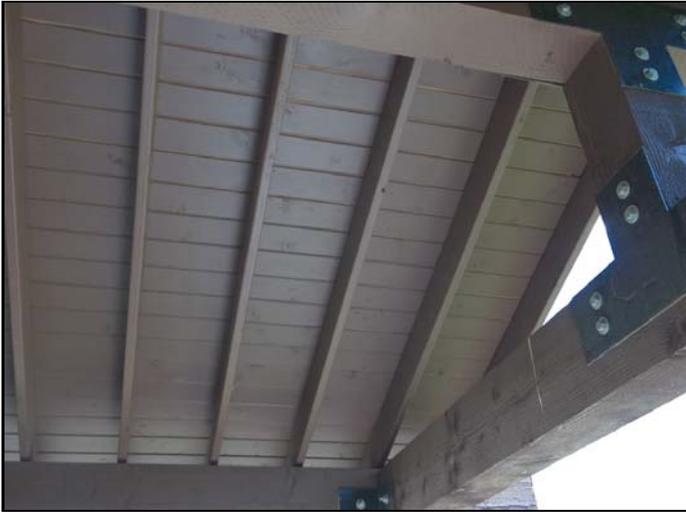
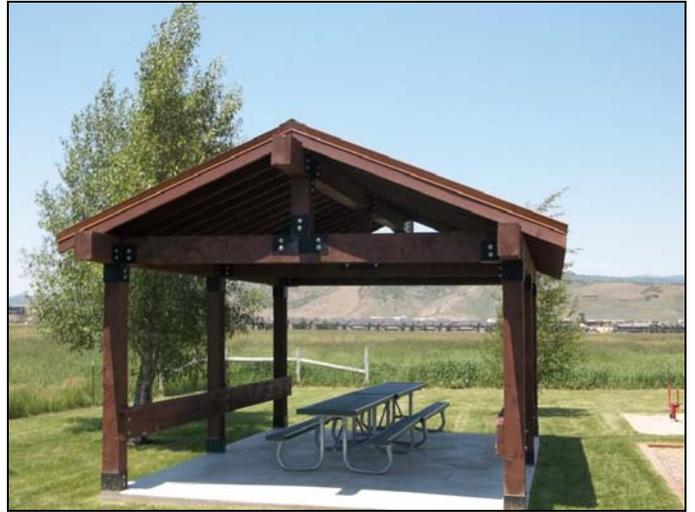
Comp #: 217 Pavilion - Repaint

The painted pavilion surfaces are in fair condition. We recommend funding to repair/repaint this component approximately every 6 - 8 years to maintain appearance and protect wood surfaces. Remaining life based on current age.

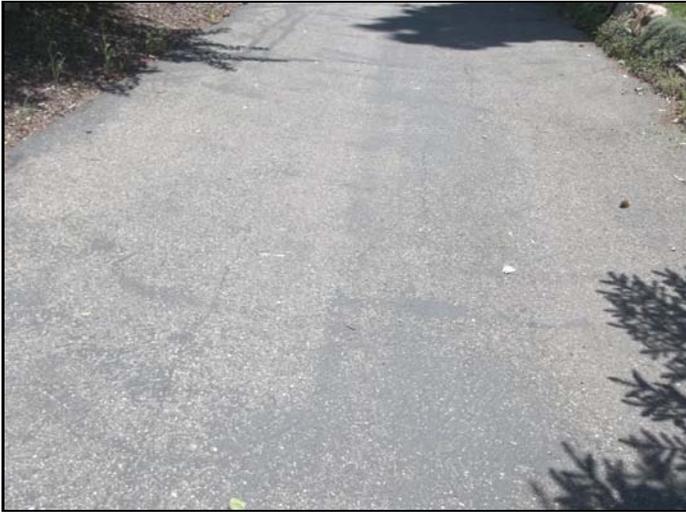
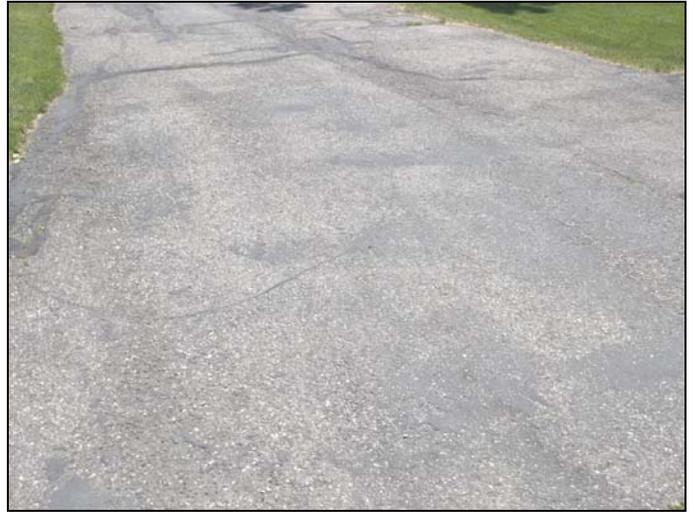
Comp #: 401 Asphalt - Major Rehab

The asphalt surfaces are in fair to poor condition. We recommend funding for a major rehab of this component approximately every 20 - 25 years. Maintain seal coat schedule to ensure full useful life (see Comp# 402 Asphalt - Seal Coat). Remaining life based on current condition.

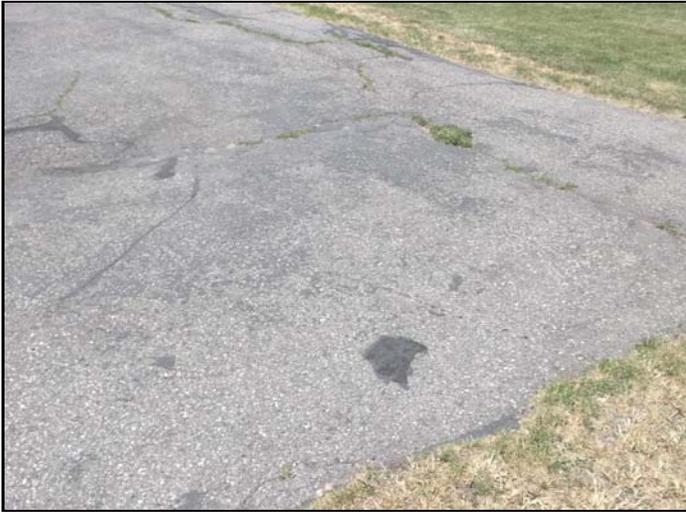
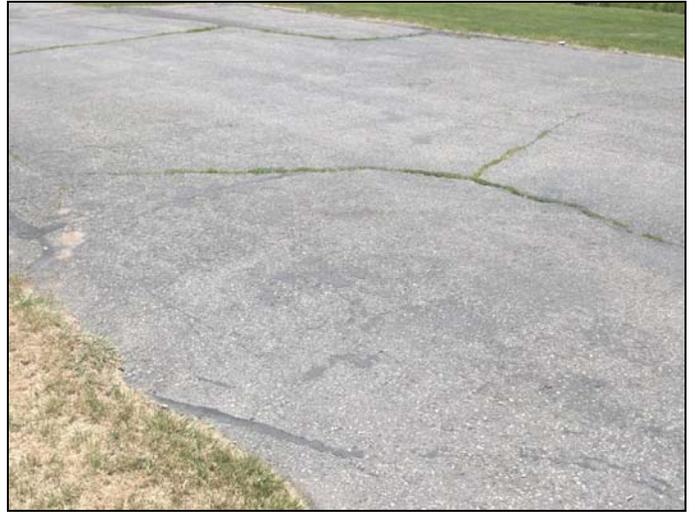
Comp #: 402 Asphalt - Seal Coat

The asphalt seal coat is in poor condition. Seal asphalt surfaces regularly to prevent premature overlay (see Comp# 401 Asphalt - Overlay). We recommend funding to seal this component approximately every 3 - 5 years. Remaining life based on current condition.

The projects programmed to occur this fiscal year (FY2018) is asphalt seal coat (Comp# 402). We have programmed an estimated \$1,500 in reserve expenditures toward the completion of this project. (See page 15)

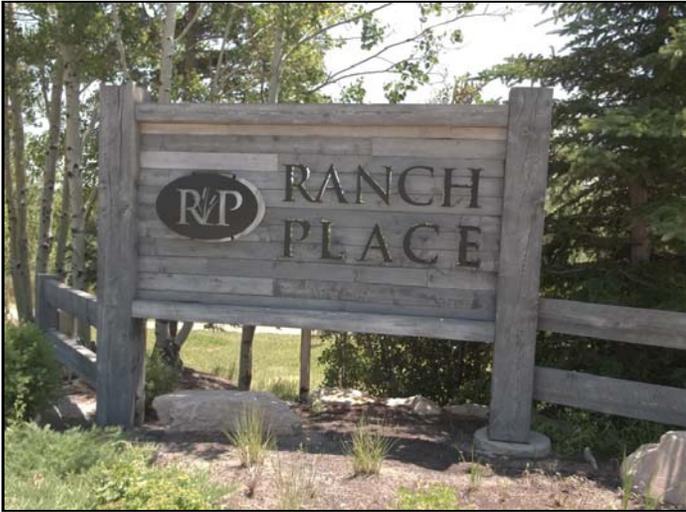
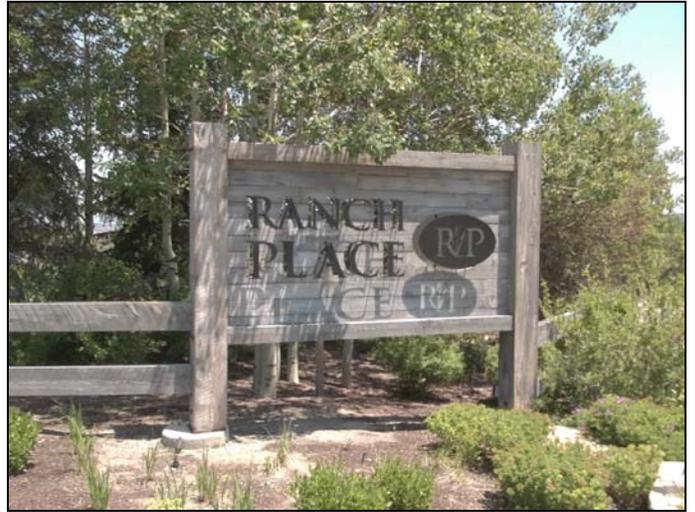
Comp #: 801 Monument Signs - Replace

The monument sign is in good condition. We recommend funding to replace this component approximately every 20 years to ensure appearance. Remaining life is based on current age.

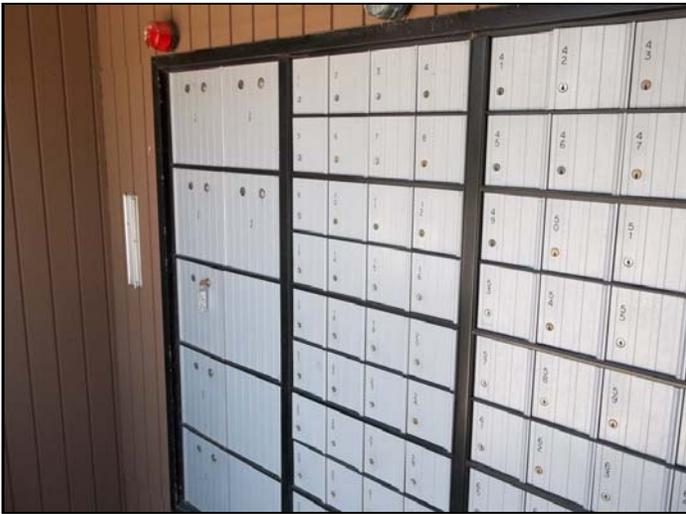
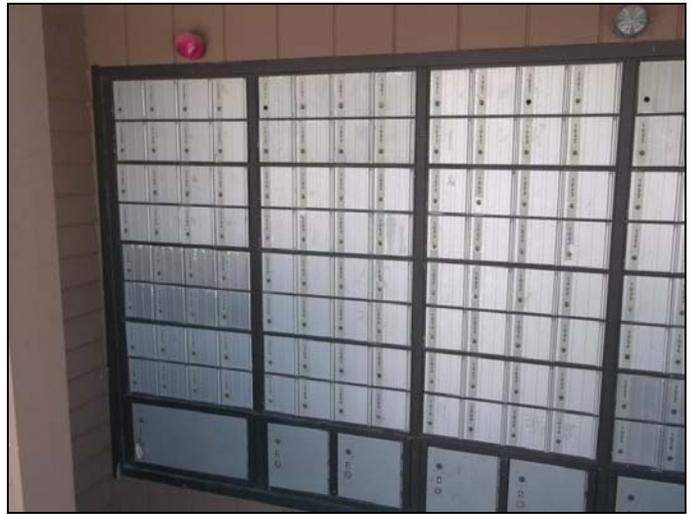
Comp #: 803 Mailboxes - Replace

Research with the client reveals this component is being replaced in 2017. We recommend funding to replace this component approximately every 20 - 30 years assuming normal use and wear. Remaining life based on current age.

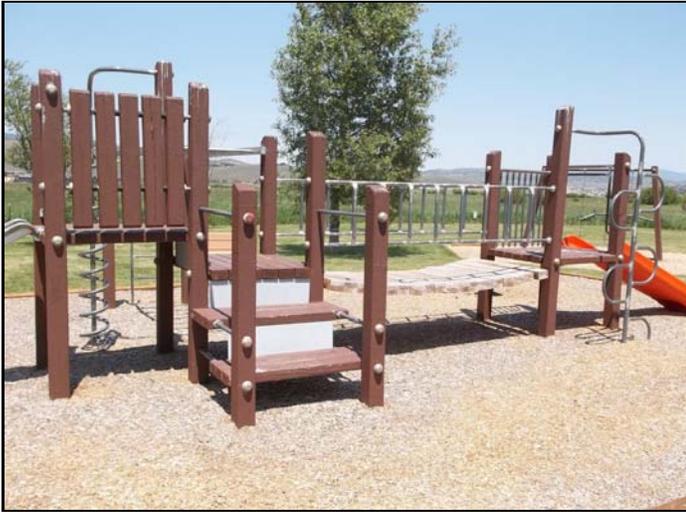
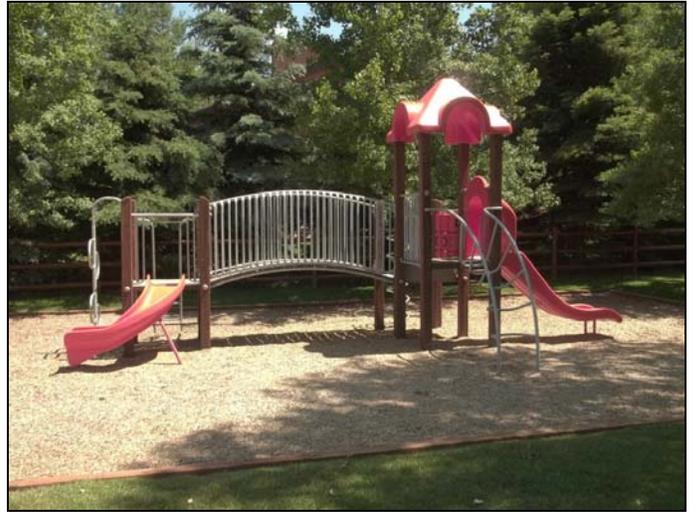
Comp #: 1301 Play Structures - Replace

The play structures are in good condition. We recommend funding to replace this component approximately every 20 - 30 years. Remaining life based on current age.

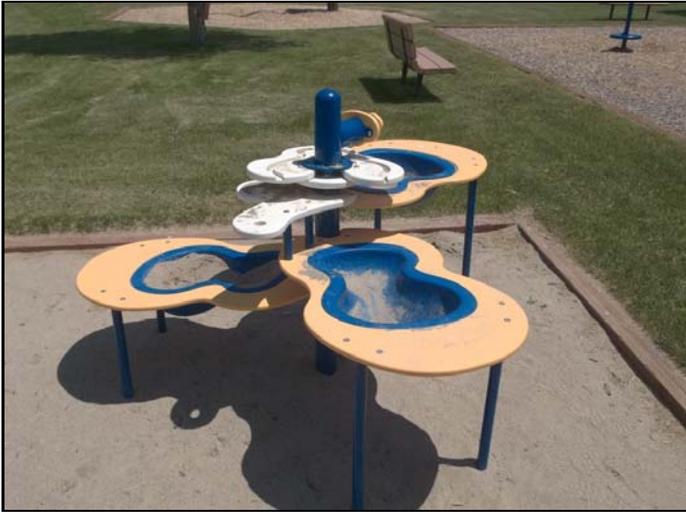
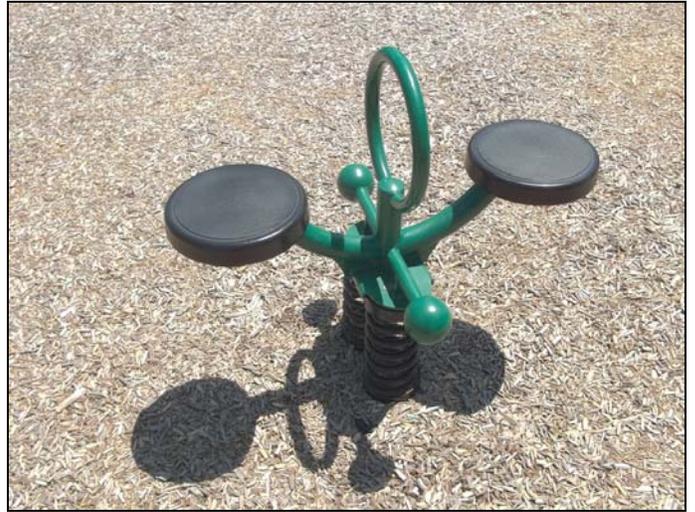
Comp #: 1301 Play Structures - West - Replace

The play structures are in good condition. We recommend funding to replace this component approximately every 15 - 20 years. Remaining life based on current age.

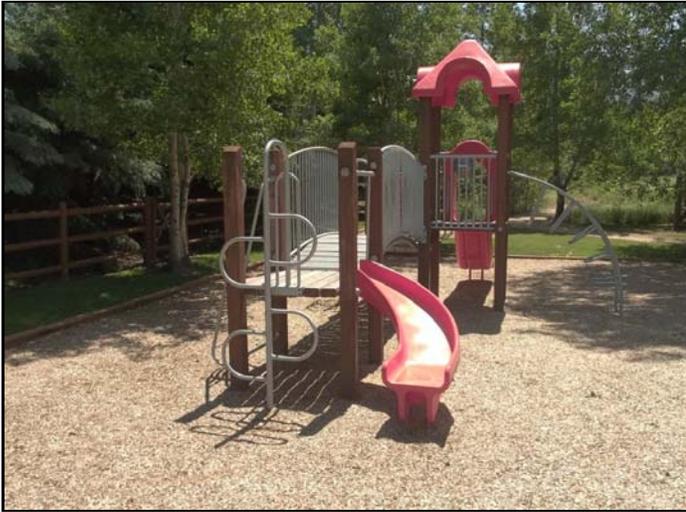
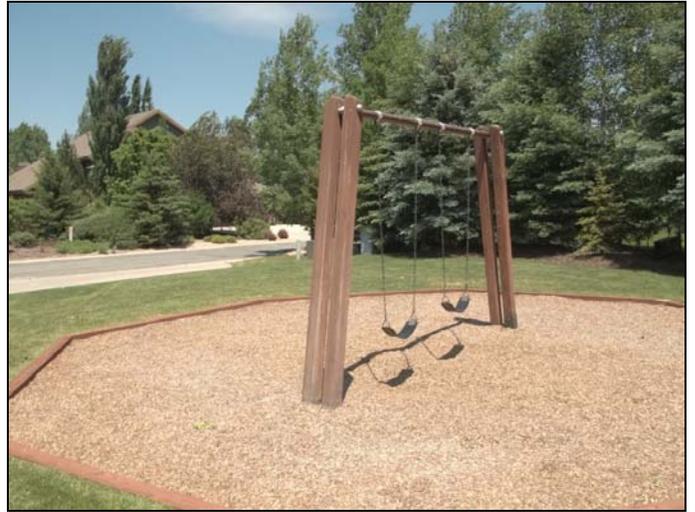
Comp #: 1303 Play Area Groundcover - East - Refill

The play area groundcover is in good to fair condition. We recommend funding to refill this component approximately every 3 - 5 years to maintain appearance and ensure proper function as a safety component. Remaining life is based on current age.

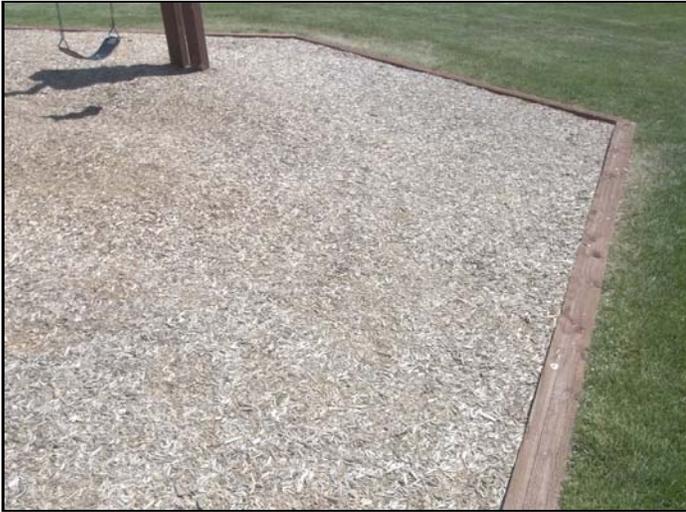
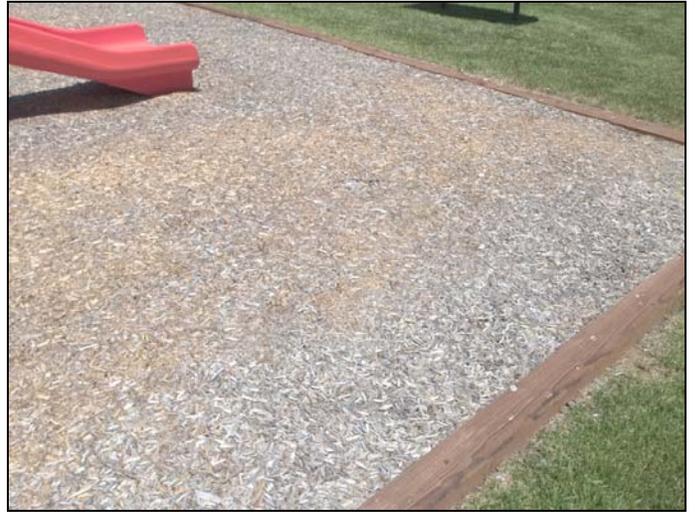
Comp #: 1303 Play Area Groundcover - West - Refill

The play area groundcover is in fair condition. We recommend funding to refill this component approximately every 3 - 5 years to maintain appearance and ensure proper function as a safety component. Remaining life is based on current age.

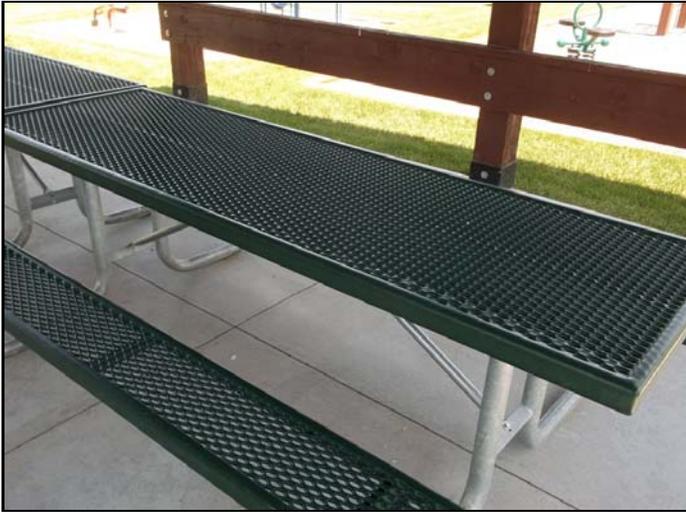
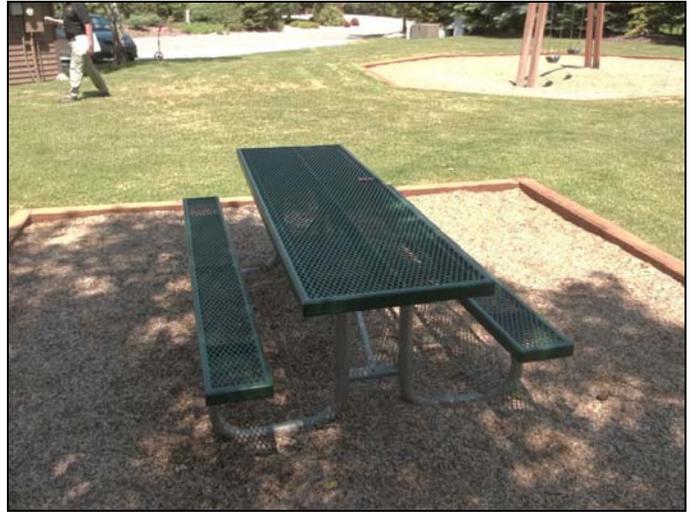
Comp #: 1306 Picnic Tables - Replace

The picnic tables are in good condition. We recommend funding to replace this component approximately every 10 - 15 years. Remaining life based on current age.

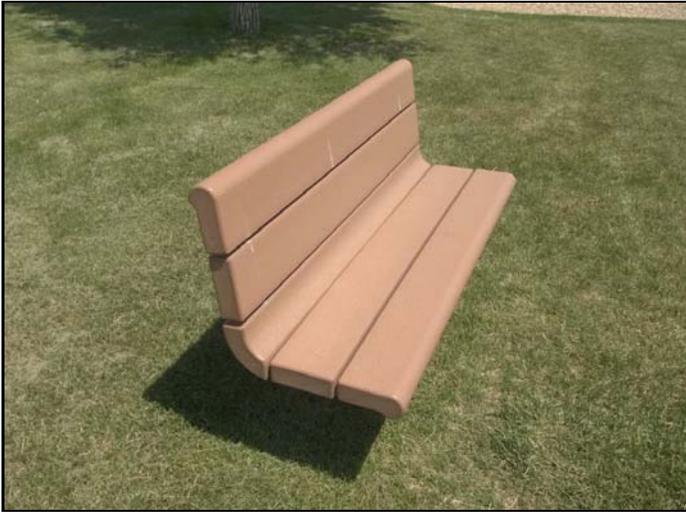
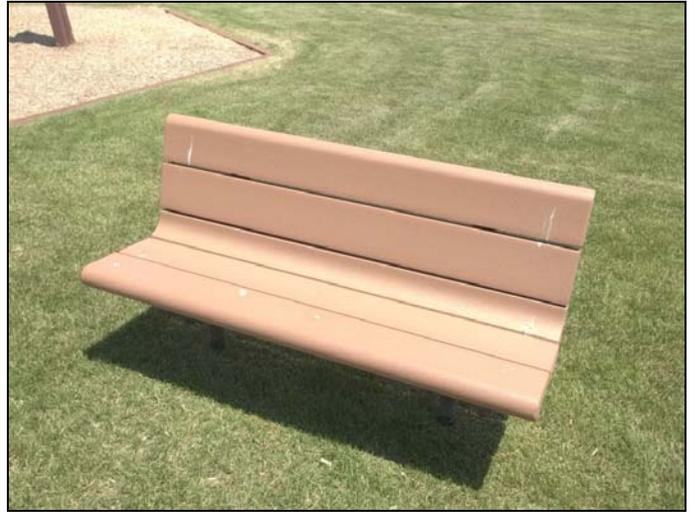
Comp #: 1307 Benches - Replace

The benches are in good condition. We recommend funding to replace this component approximately every 10 - 15 years. Remaining life based on current age.

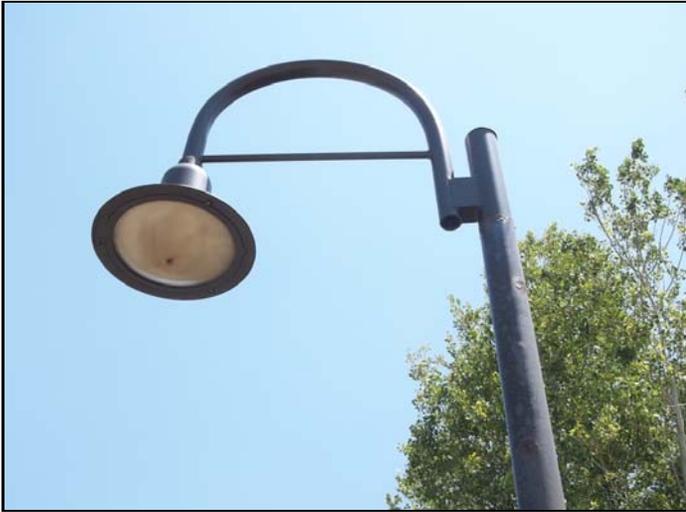
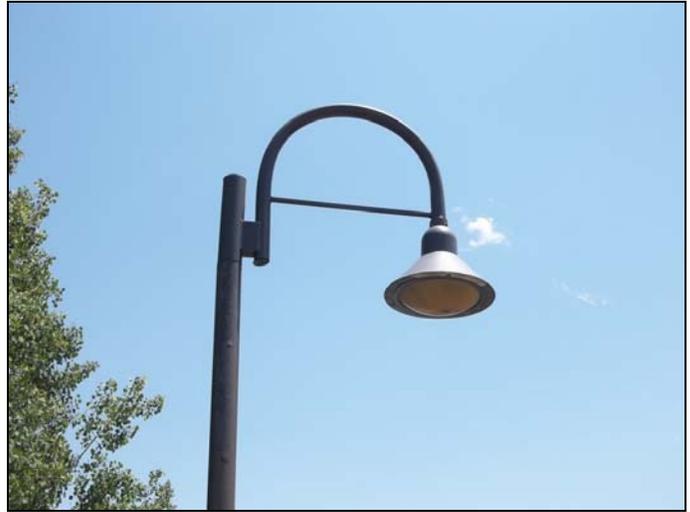
Comp #: 1609 Street Light Fixtures - Replace

The street light fixtures are in good condition. No expectation to replace the light poles. Paint poles as necessary as an operating expense. We recommend funding to replace this component approximately every 20 years to ensure proper function. Remaining life based on current age.

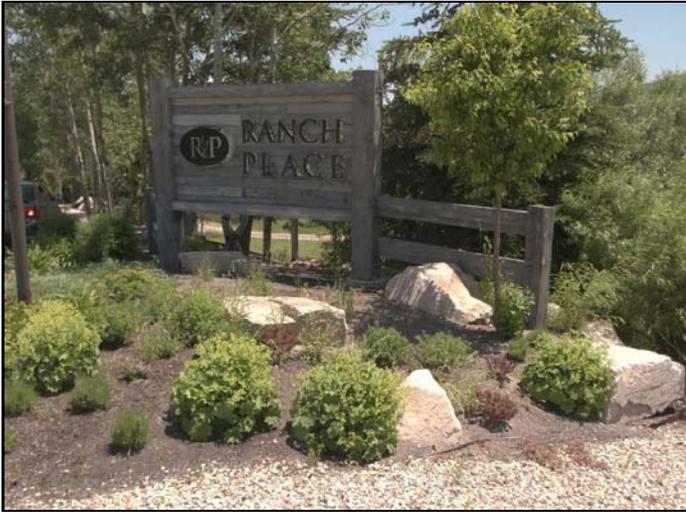
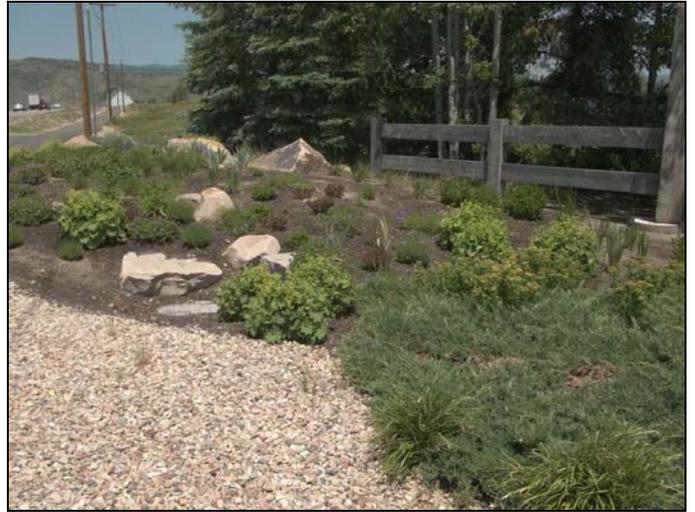
Comp #: 1812 Landscaping & Irrigation System - Renovate

The landscaping and irrigation system are in good condition. We recommend funding for an allowance to renovate the landscaping and irrigation system approximately every 20 years. Remaining life based on current age.
