Ranch Place HOA

Level 2 Reserve Study

Report Period – 01/01/2024 – 12/31/2024

Executive Summary – Ranch Place HOA - ID # 18338

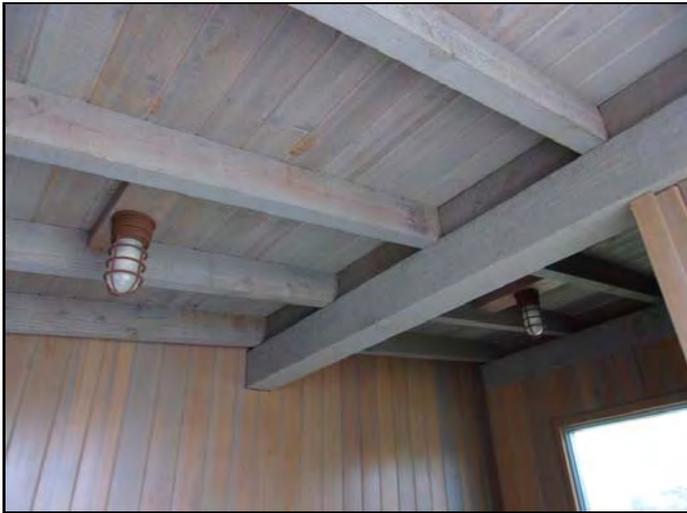
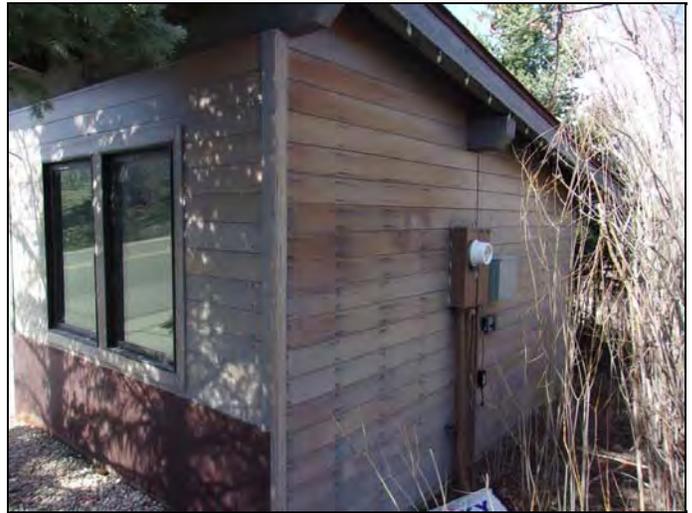
Comp #: 215 Mailbox Kiosks - Repaint

Location: **Community Entrance & East Park Area**

The painted surfaces are in good to fair condition. We recommend funding to repair/repaint this component approximately every 6 - 8 years. Remaining life is based on current age.

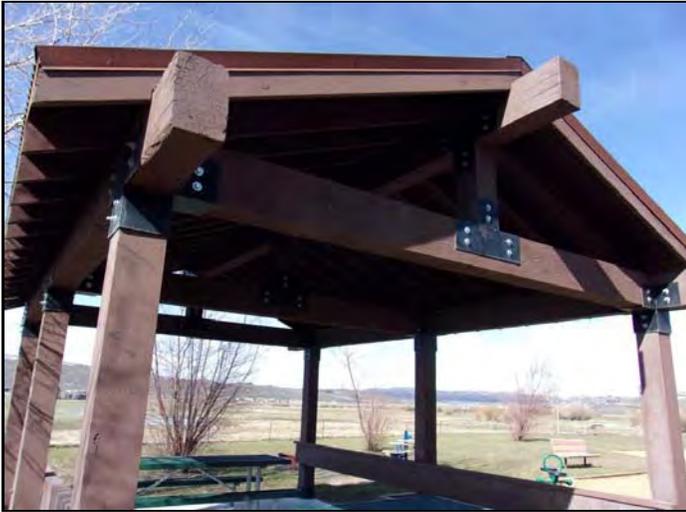
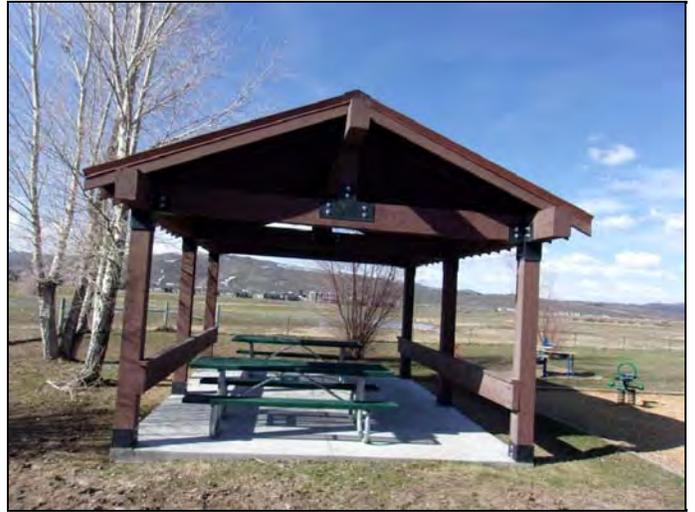
Comp #: 217 Pavilion & Play Structures - Repaint

Location: **West Playground**

Research with the client reveals this component will be repainted in 2024. We recommend funding to repaint this component approximately every 4 - 6 years. Remaining life based on current age.

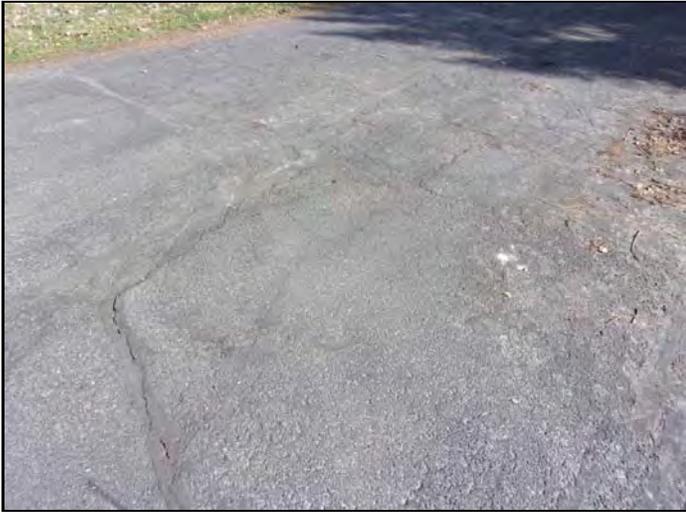
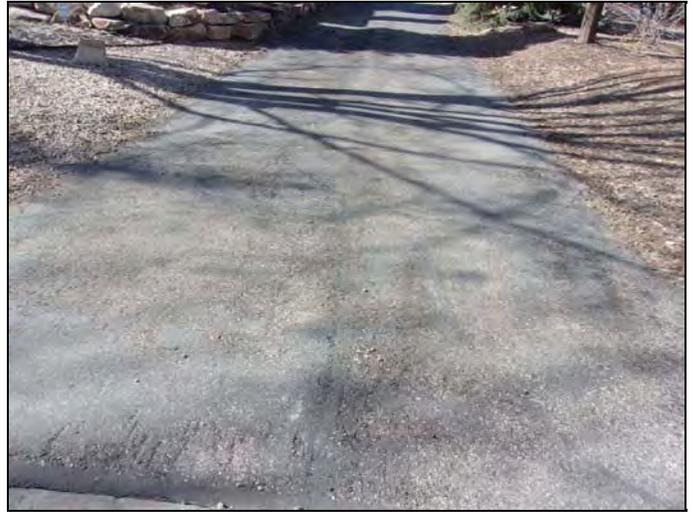
Comp #: 401 Asphalt - Major Rehab

Location: **Playground Road & Parking Area**

The asphalt surfaces are in fair to poor condition. We recommend funding for a major rehab of this component approximately every 25 - 30 years. Remaining life based on current age and condition

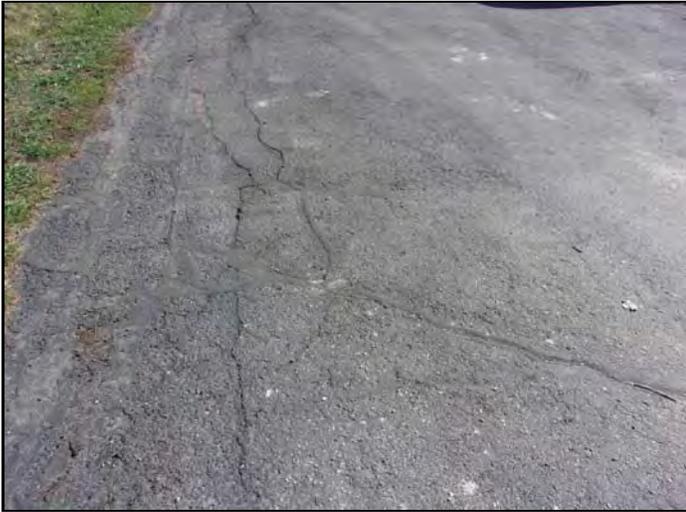
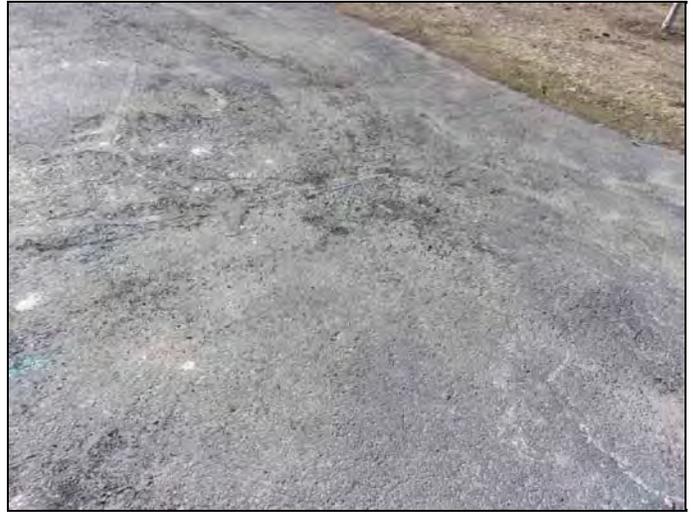
Comp #: 402 Asphalt - Seal Coat

Location: **Playground Road & Parking Area**

The asphalt seal coat is in poor condition. We recommend funding to seal this component approximately every 3 - 5 years. Remaining life based on current condition.

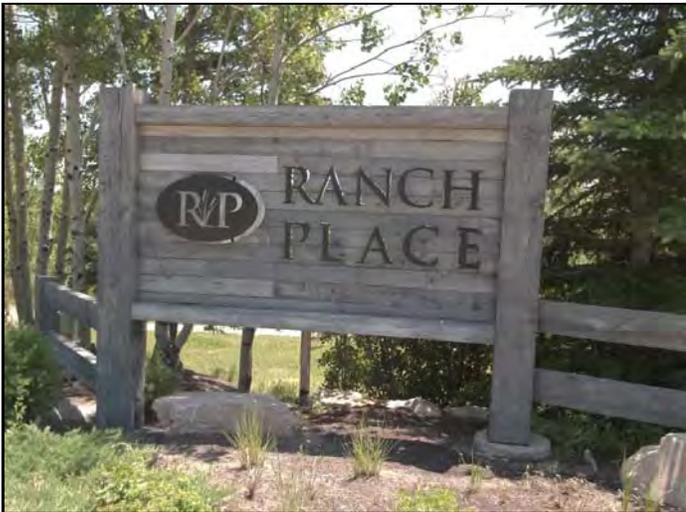
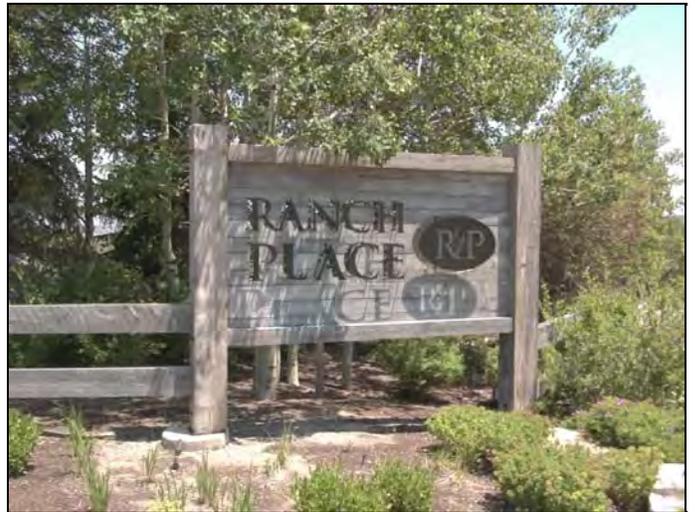
Comp #: 801 Monument Signs - Replace

Location: **Community Entrance**

The monument signs are in good condition. Research with the client reveals they plan to replace this component every 30 years. Remaining life is based on current age.

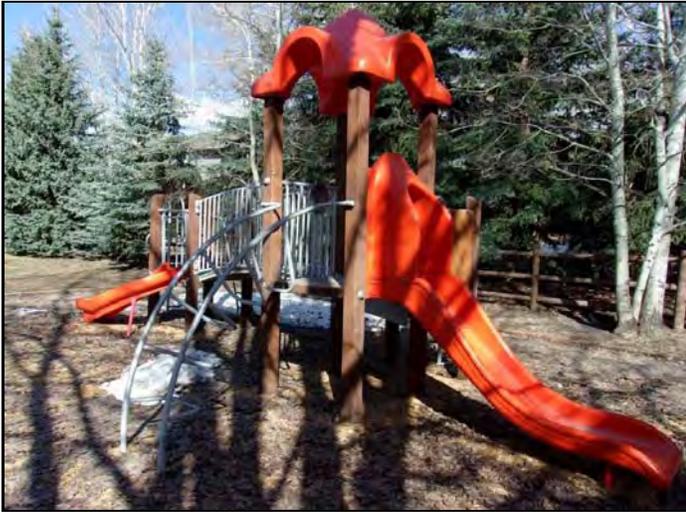
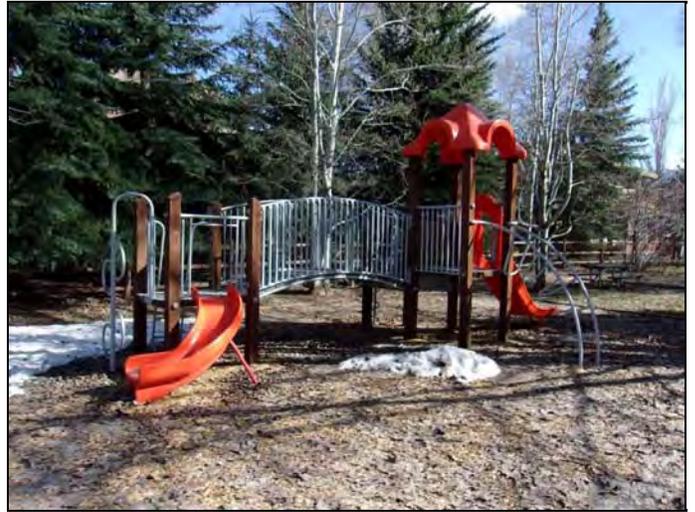
Comp #: 1301 Play Structures - 2000 East - Replace

Location: **East Park Area**

The play structures are in fair condition. We recommend funding to replace this component approximately every 20 - 30 years. Remaining life based on current age.

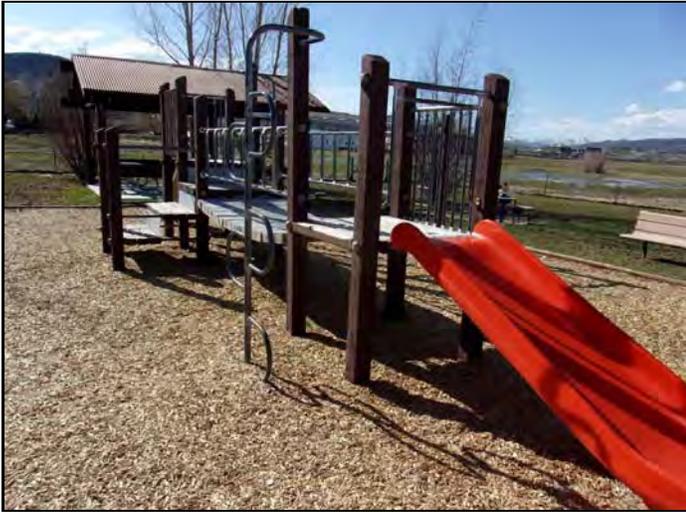
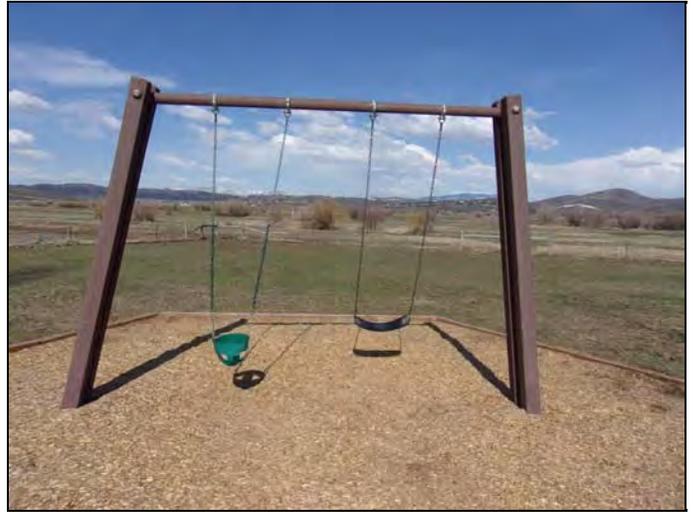
Comp #: 1301 Play Structures - 2000 West - Replace

Location: **West Park Areas**

The play structures are in fair condition. We recommend funding to replace this component approximately every 20 - 30 years. Remaining life based on current age.

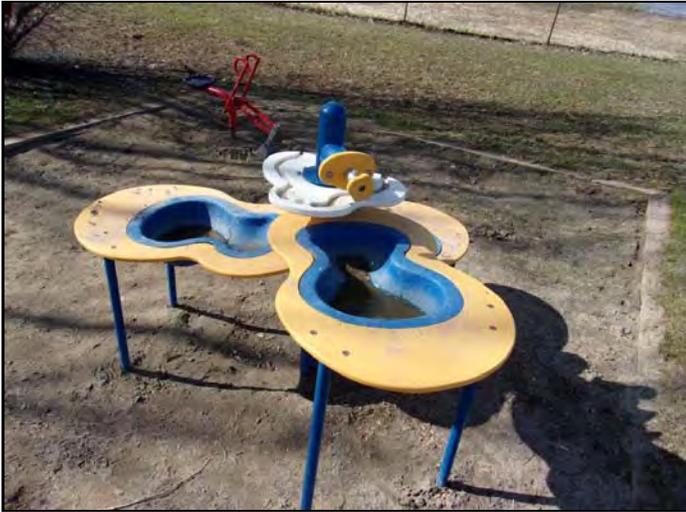
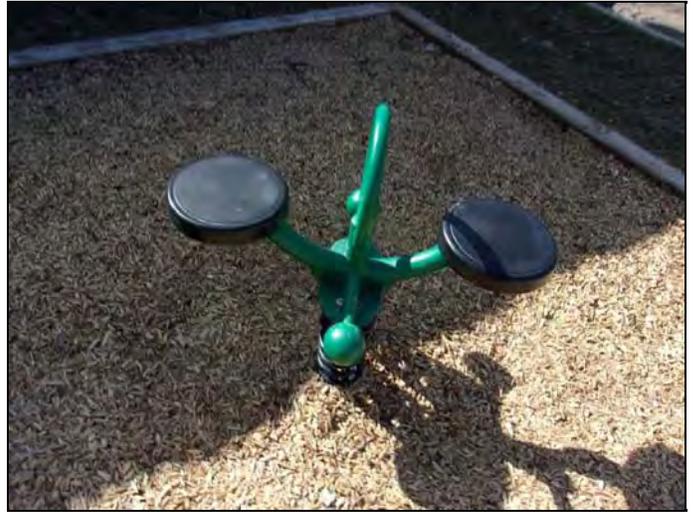
Comp #: 1301 Play Structures - 2014 West - Replace

Location: **West Park**

The play structures are in good condition. We recommend funding to replace this component approximately every 15 - 20 years. Remaining life based on current age.

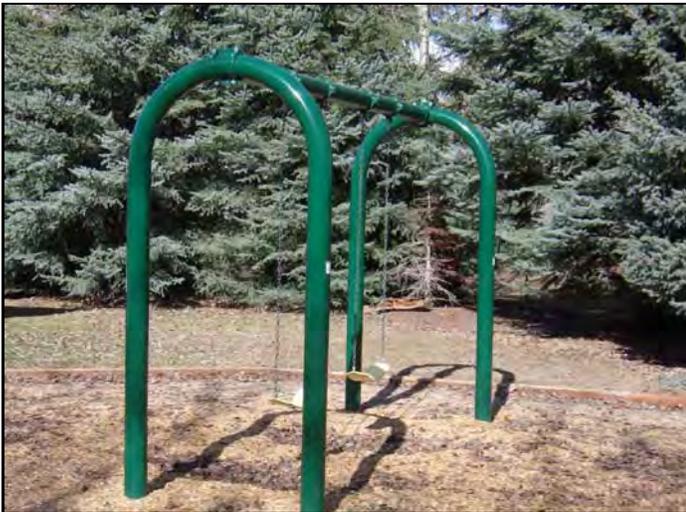
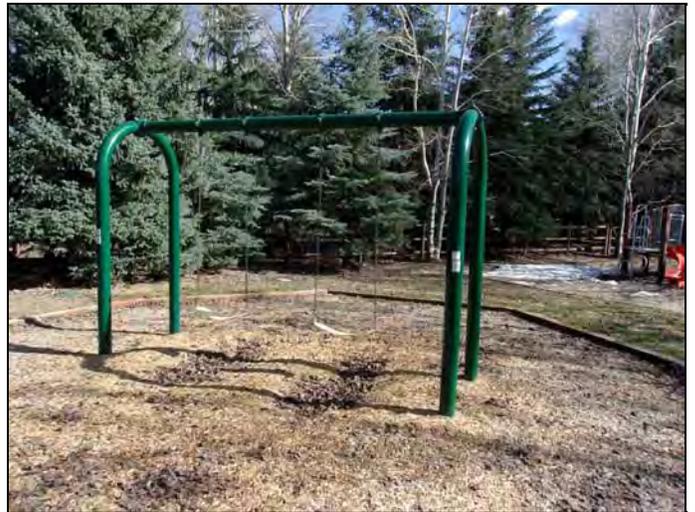
Comp #: 1302 Swing Set - Replace

Location: **East Park**

The swing set is in good condition. We recommend funding to replace this component approximately every 30 - 40 years. Remaining life based on current age.

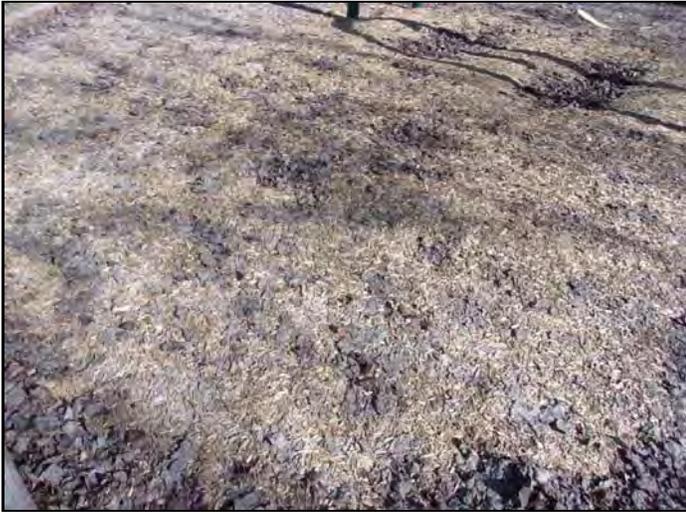
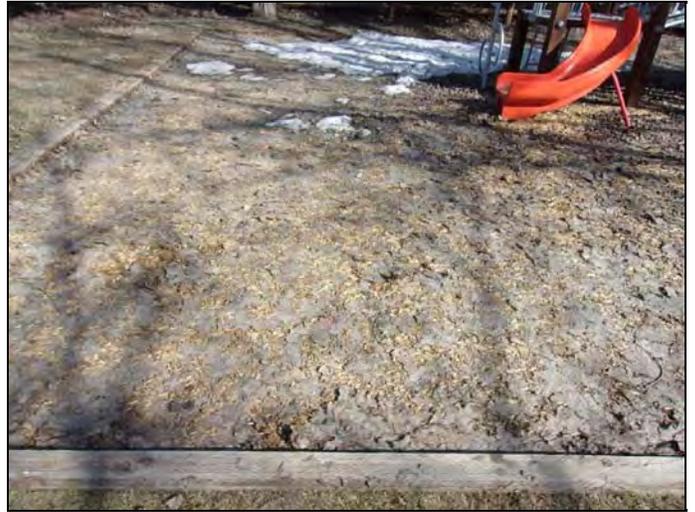
Comp #: 1303 Play Area Groundcover - East - Refill

Location: **East Playground**

The play area groundcover is in fair condition. We recommend funding to refill this component approximately every 3 - 5 years. Remaining life is based on current age.

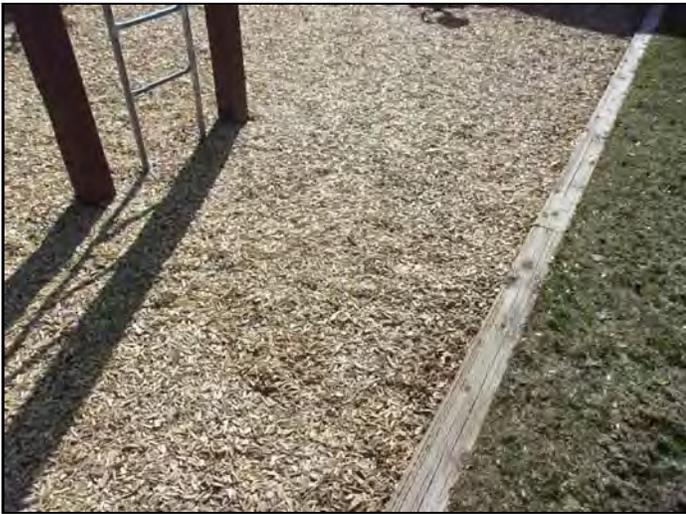
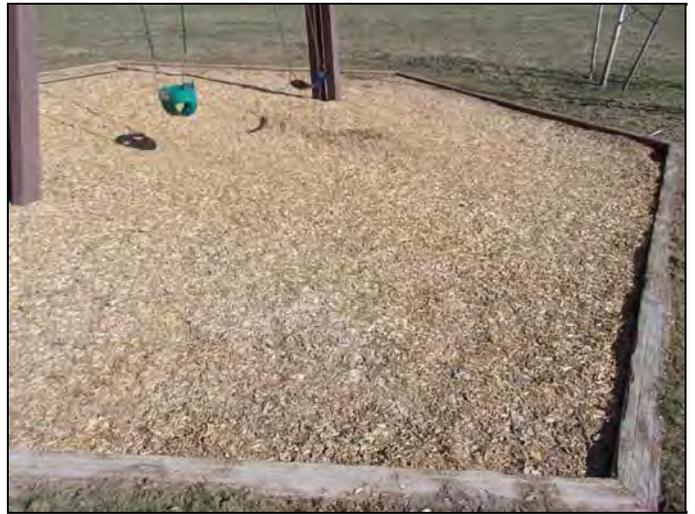
Comp #: 1303 Play Area Groundcover - West - Refill

Location: **West Playground**

The play area groundcover is in good condition. We recommend funding to refill this component approximately every 3 - 5 years. Remaining life is based on current age.

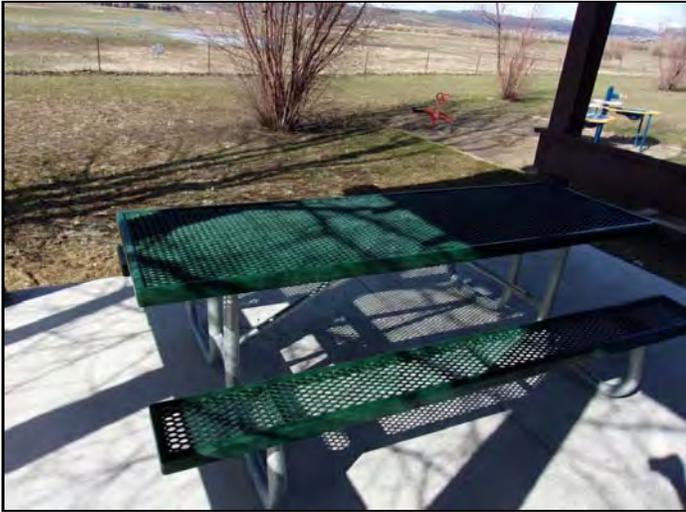
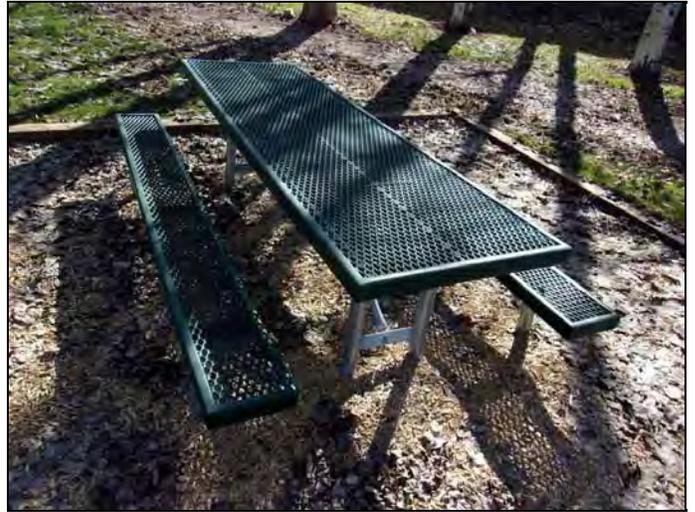
Comp #: 1306 Picnic Tables - Replace

Location: **Park Areas**

The picnic tables are in fair condition. Research with the client reveals they plan to replace this component every 20 years. Remaining life based on current age.

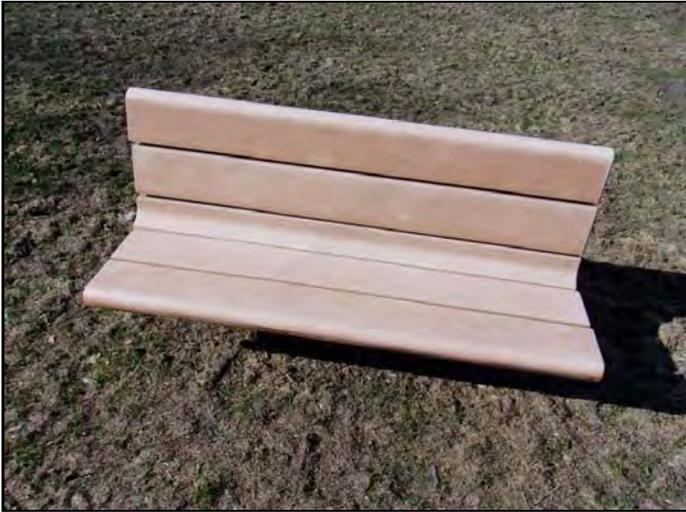
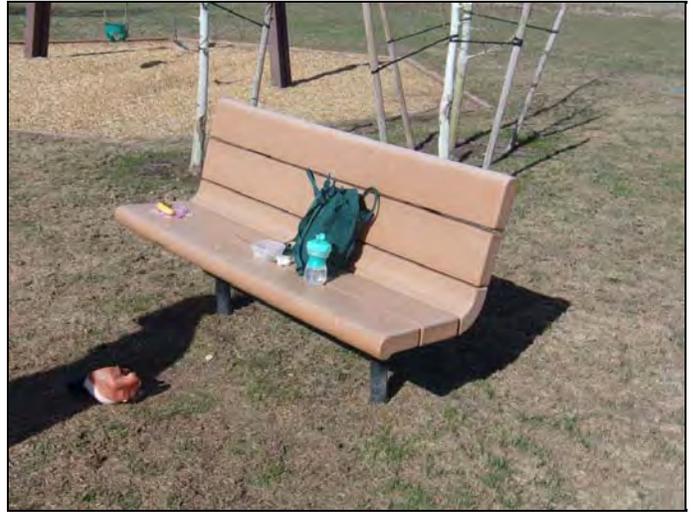
Comp #: 1307 Benches - Replace

Location: **West Park**

The benches are in fair condition. Research with the client reveals they plan to replace this component every 20 years. Remaining life based on current age.

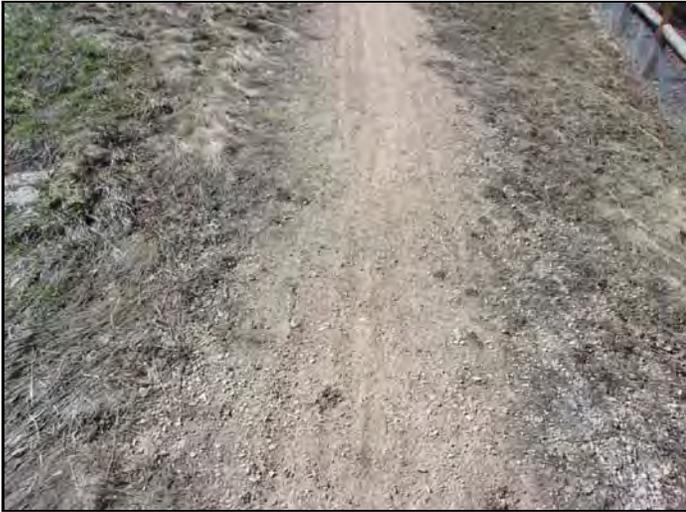
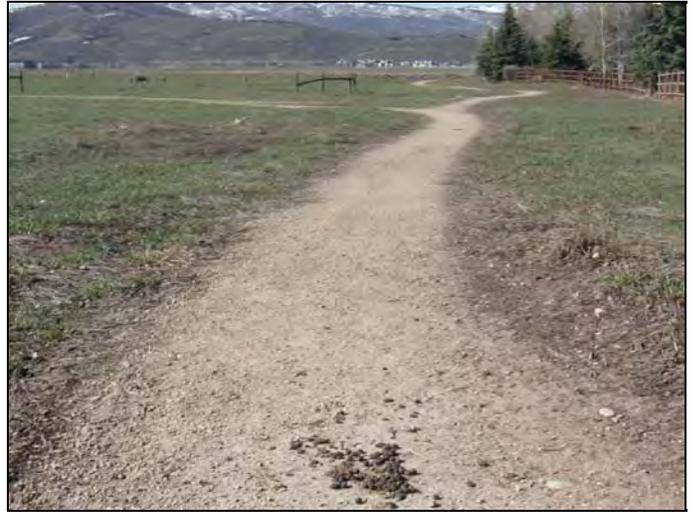
Comp #: 1390 Trails - Resurface

Location: **Common Area**

Quantity: **Approx 2.5 Miles**

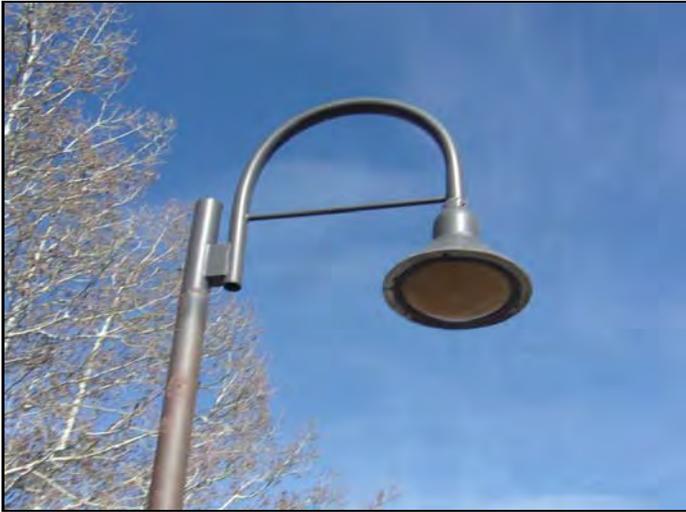
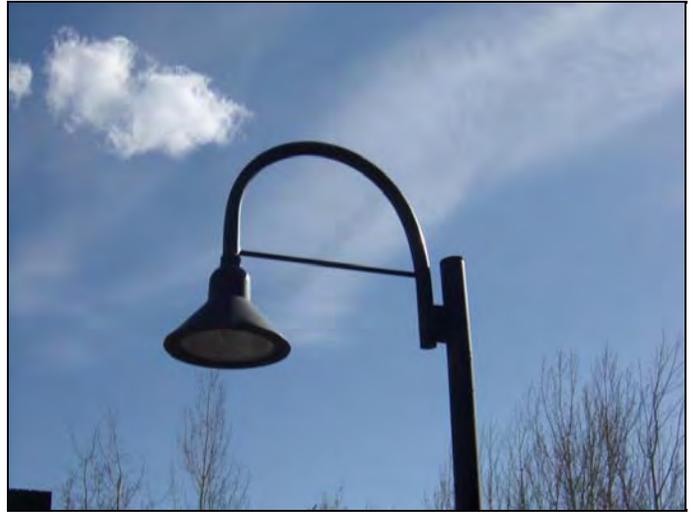
Comp #: 1609 Street Light Fixtures - Replace

Location: **Adjacent to Community Roads**

The street light fixtures are in working condition. No expectation to replace the light poles. Paint poles as necessary as an operating expense. Research with the client reveals they plan to replace this component every 30 years. Remaining life based on current age and condition.

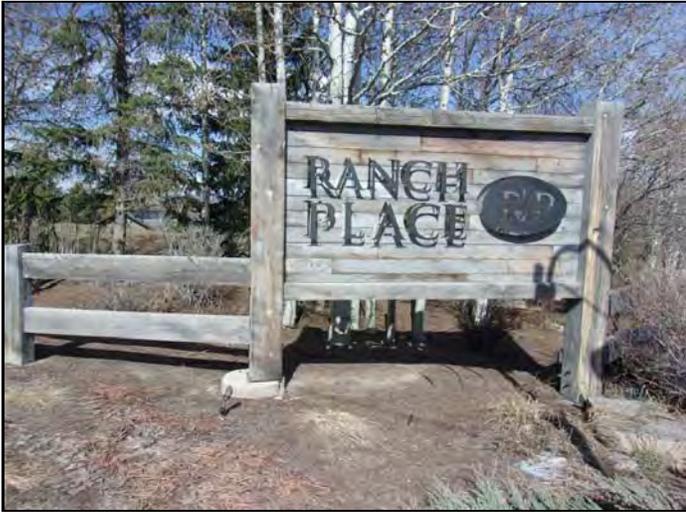
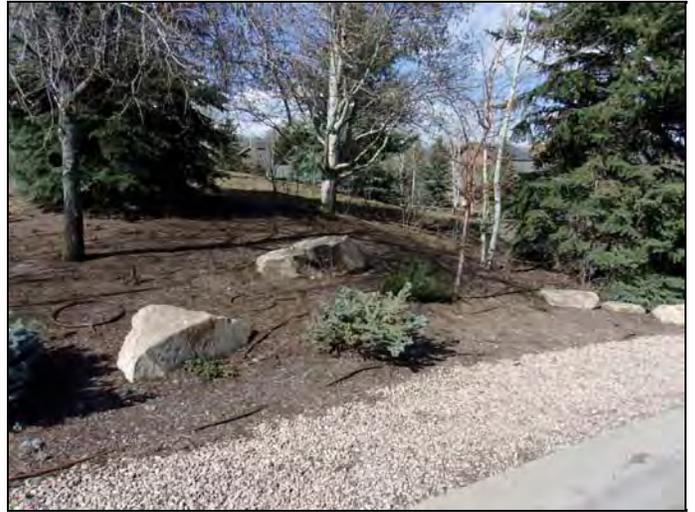
Comp #: 1801 Landscaping Mulch - Replenish

Location: **Common Area**

Research with the client reveals this component will be replenished in 2023. We recommend funding to replenish this component approximately every 2 - 3 years. Remaining life based on current age.

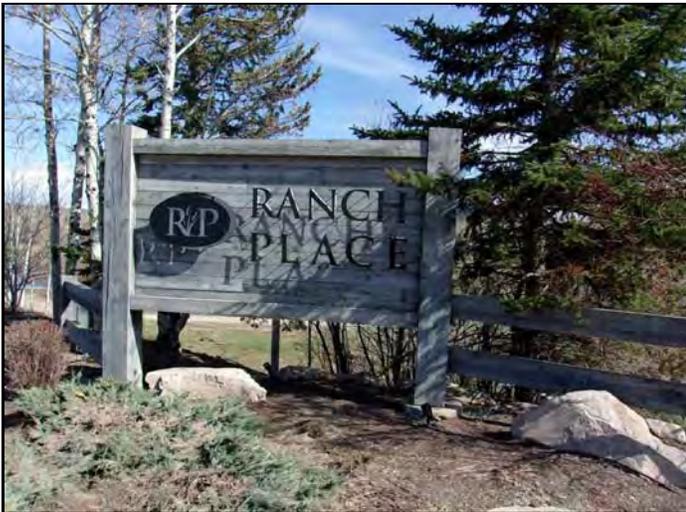
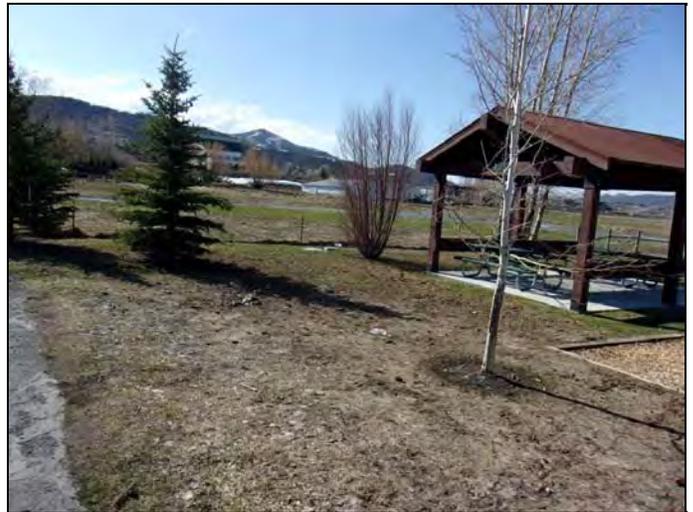
Comp #: 1812 Landscaping & Irrigation System - Renovate

Location: **Common Area**

The landscaping and irrigation system appear to be in fair condition. We recommend funding for an allowance to renovate this component approximately every 10 years. Remaining life based on current age.

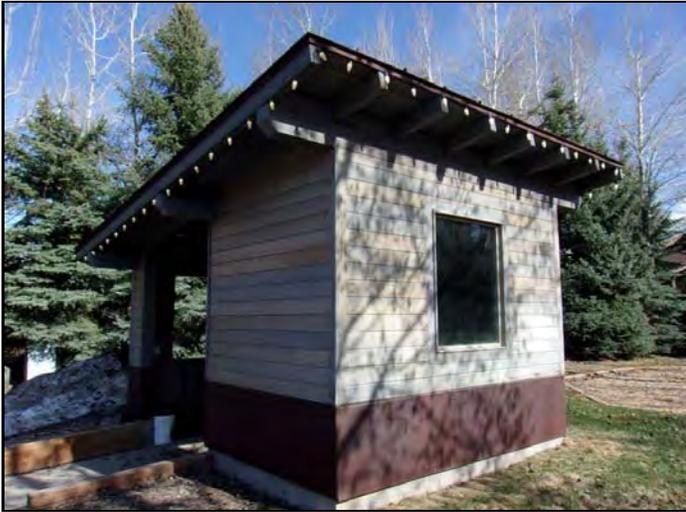
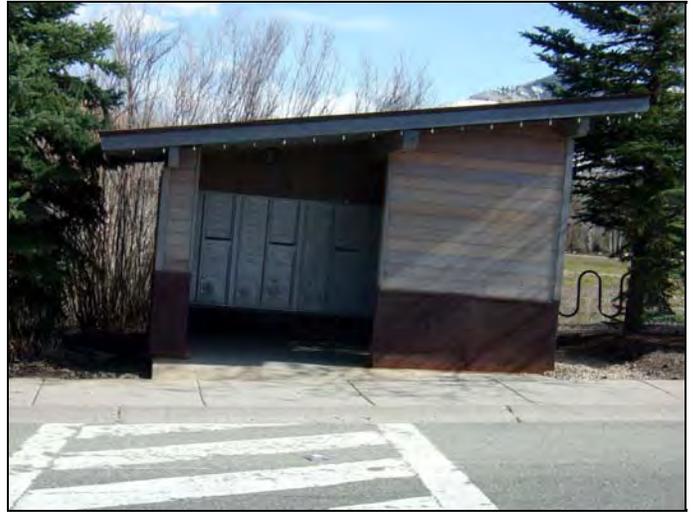
Comp #: 2303 Mailbox Kiosks - Replace

Location: **Community Entrance & East Park Area**

The mail kiosks are in good condition. The client plans to replace this component approximately every 30 years. Remaining life based on current age.
